# Lab/Cor Materials, LLC

Form #: T06-13 **Official Test Report**

### Failure Analysis

This report contains the results of characterization of the solid deposits causing blockage inside the RFI reactor and outlet tube. Samples were submitted by John Smith on 8/22/14.

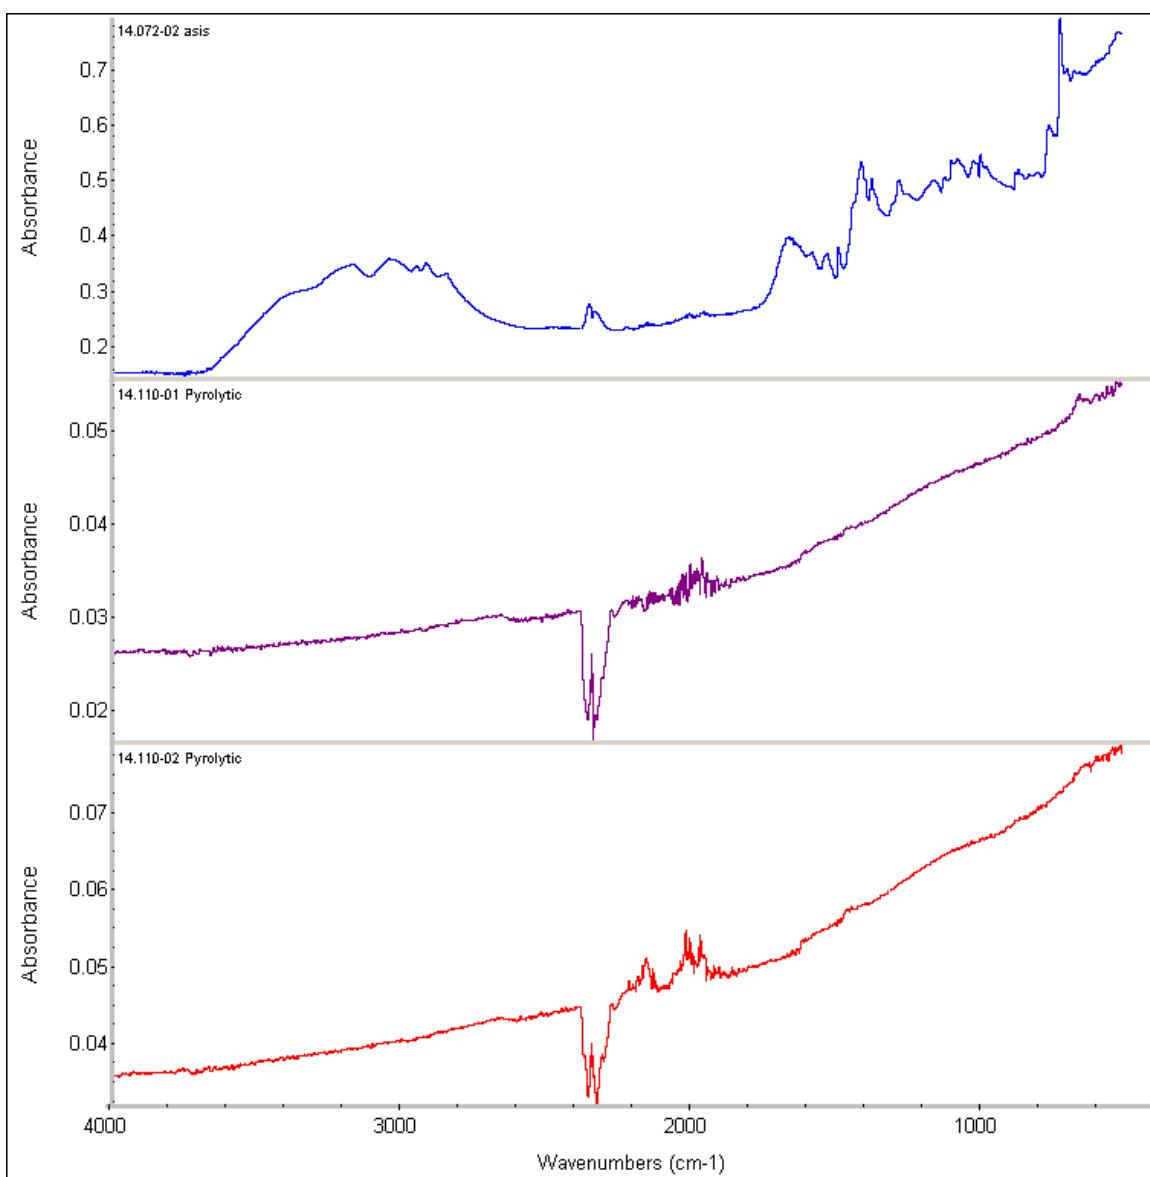
Infrared spectra of both regions of the sample are featureless except for very minor peaks in the 1400-1600 cm<sup>-1</sup> region (Figure 1) and a peak near 600 cm<sup>-1</sup> in sample 14.999-01a. The lack of major peaks is indicative of a nearly pure elemental substance, which we can conclude is carbon based on the rest of the results below. The small features are likely due to impurities trapped in the carbon deposits. The relatively weak intensity of the peaks makes it impossible to determine the specific nature of the impurities and suggests they are present only in trace amounts with a slightly higher concentration in sample 14.999-01a (consistent with other results).

**Figure 1.** FTIR spectra of asphaltenes (blue), 14.999-01a (purple), and 14.999-01b (red). Note the difference in absorbance scales. The features in the 1900-2200 cm<sup>-1</sup> region are due to atmospheric interferences from H<sub>2</sub>O and CO<sub>2</sub>. The figure clearly shows the lack of asphaltene features and the featureless nature of the sample spectra.

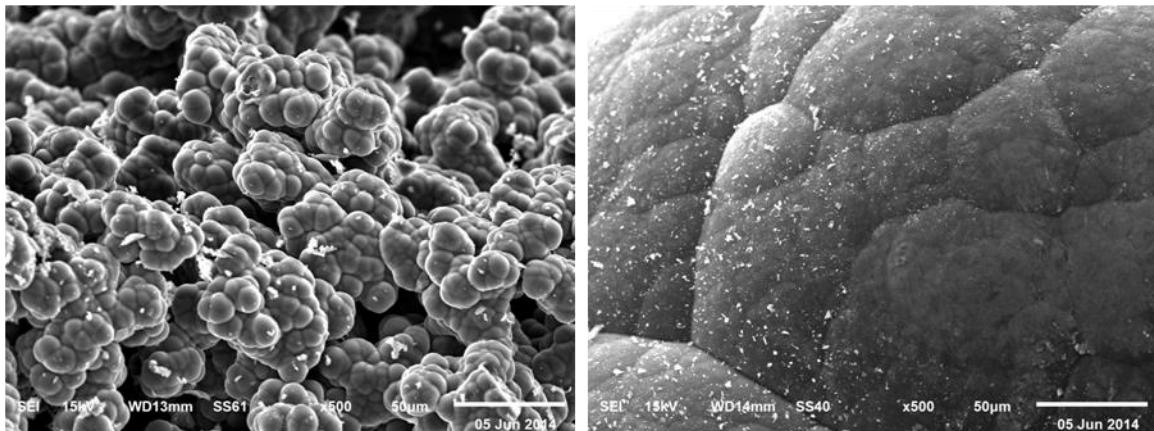
SEM images of the material show that 14.999-01b has a much smoother structure than 14.999-01a (Figure 2). This difference indicates that the shiny deposits found hotter regions of the reactor have been annealed. The EDS quantitative elemental analysis shows a very high carbon concentration in both samples. Sample 14.999-01b has a higher carbon level, lower oxygen and sulfur levels, and no detectable metals. This serves as further evidence of annealing at high temperature, which would remove oxygen and sulfur.

**Figure 2.** SEM images of 14.999-01a (left) and 14.999-01b (right) show the difference between the rough, granular structure of deposits from cool regions and the smooth structure of deposits from the hotter regions.

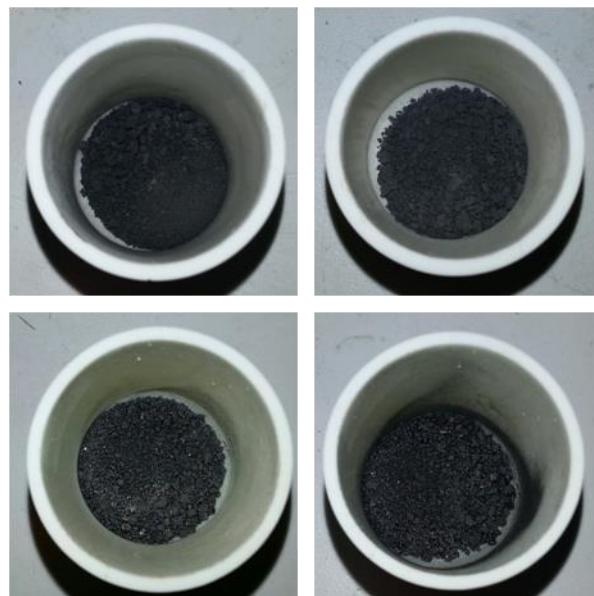
The samples were subjected to the following temperatures (°C) under ambient air: 21, 325, 477, 488, 493, 499, 504, 510, 538, 550, 593, 649, and 850. The samples remained solid throughout the experiment, never melting or gasifying to a large extent. The appearance of the samples did not change (Figure 3). The bulk of the material is stable at high temperatures, indicating that the deposits are a highly-ordered, graphite-like structure resulting from the deposition process from gas-phase hydrocarbons and the

**Figure 3.** Photos of samples 14.999-01a (top) and 14.999-01b (bottom) show little change in appearance before (left) and after (right) exposure to temperatures as high 850 °C.
